AP3 Ultra-thin Polymer Windows manufactured at Moxtek® receive two quality inspections before being shipped to customers, once before installation into various mounts and once at final inspection directly before packaging and after helium leak check. Our first quality inspection includes a microscope inspection at 50X with both reflected and transmitted light. The second inspection includes a 100X inspection with both reflected and transmitted light. Additionally some customers inspect the windows before installing them into their products.

The following is a guideline for inspecting thin AP3 windows with some examples of what Moxtek has found are acceptable and not acceptable for suitable reliability of the window. Included are examples of defects that Moxtek has found on windows and what are considered acceptable levels or sizes of defects.

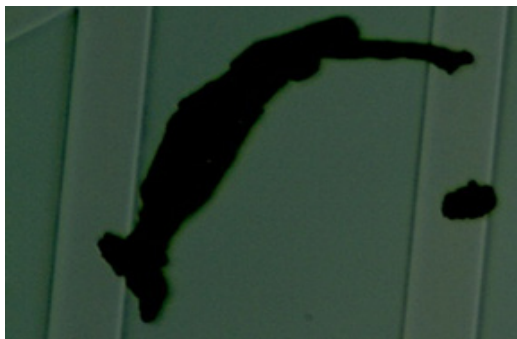
Figure 2 Particle size is less than 1/2 the width of the pane area therefore, acceptable.

Parts will be rejected for specks if the particle size is greater than 1/2 the width of the window pane and positioned on the front surface as viewed in reflected light or any sized particles defined as 10 or more in the 100x field of view on the backside of the film as seen under transmitted light. Any particles that may be internal to the film are rejected at Moxtek. Figure 2 shows an example of an acceptable speck on the front surface while Figure 3 shows an example of an unacceptable speck on the front surface.

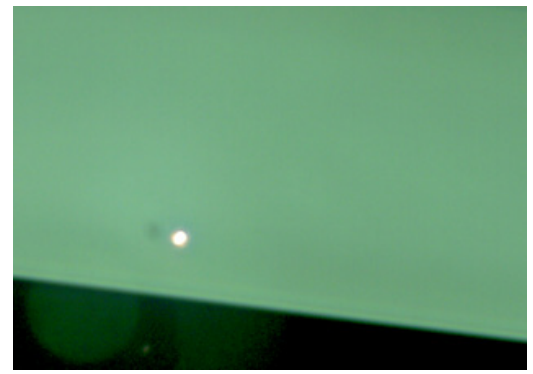
Light leak defects are found by inspecting with transmitted light and can be the cause of a pin hole vacuum leak through the film. Possible causes are accelerated particles puncturing the film after venting parts under vacuum. Figure 5 shows a light leak example. All light leaks are rejected at Moxtek.

Figure 5 All light leaks are rejected at Moxtek.

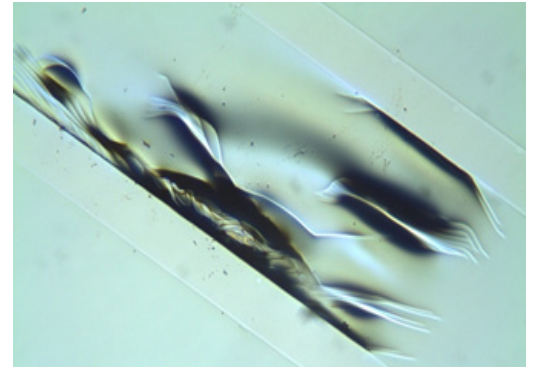
Damage to the film is usually caused by anything coming in contact with the thin film surface of the window. Moxtek takes exceptional precautions in handling these parts during manufacturing and packaging. The sensitive nature of the film dictates special handling procedures and a conscious effort to avoid contact of the film with any other surface. All film damage is rejected at Moxtek since it would cause a non-hermetic seal. Figure 6 is an example of film damage.

Figure 6 Film damage between two ribs due to contact of the film, rejected.

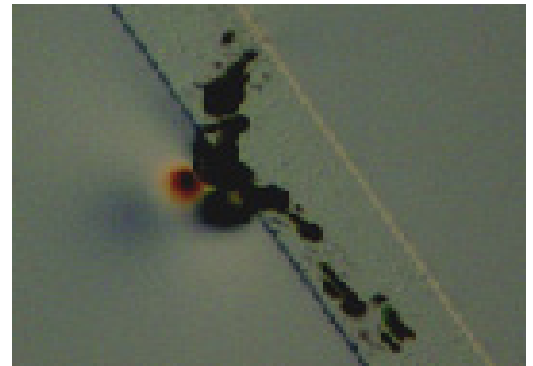
Contamination is defined as anything on the surface of the film that is not a single point defect. For example any liquid, paste, gel or powder would be considered contamination. Figure 7 shows an example of contamination on the film. Any contamination is rejected at Moxtek.

Figure 7 Contamination on a pane rib, rejected.

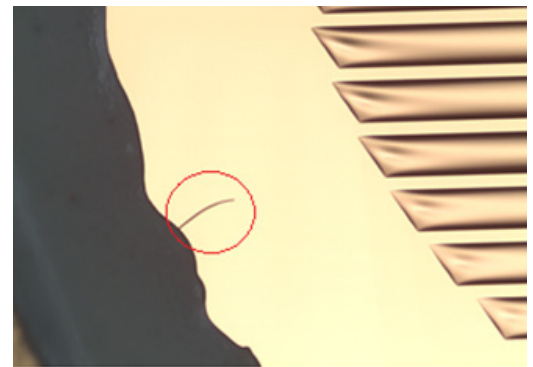
Wrinkles in the film are more of a cosmetic issue than a structural problem. These are areas where the thin film of the window folds on itself during the manufacturing process. Moxtek does not use windows with any film wrinkles that extend more than half way across the flange area. Figure 8 shows an acceptable wrinkle.

Figure 8 Wrinkle in film that is not more than half way across the flange, acceptable.
